DOT/FAA/CT-82/153
DOT/FAA/RD-82/85

Evaluation of Precision Approach Path Indicator (PAPI)

Final Report

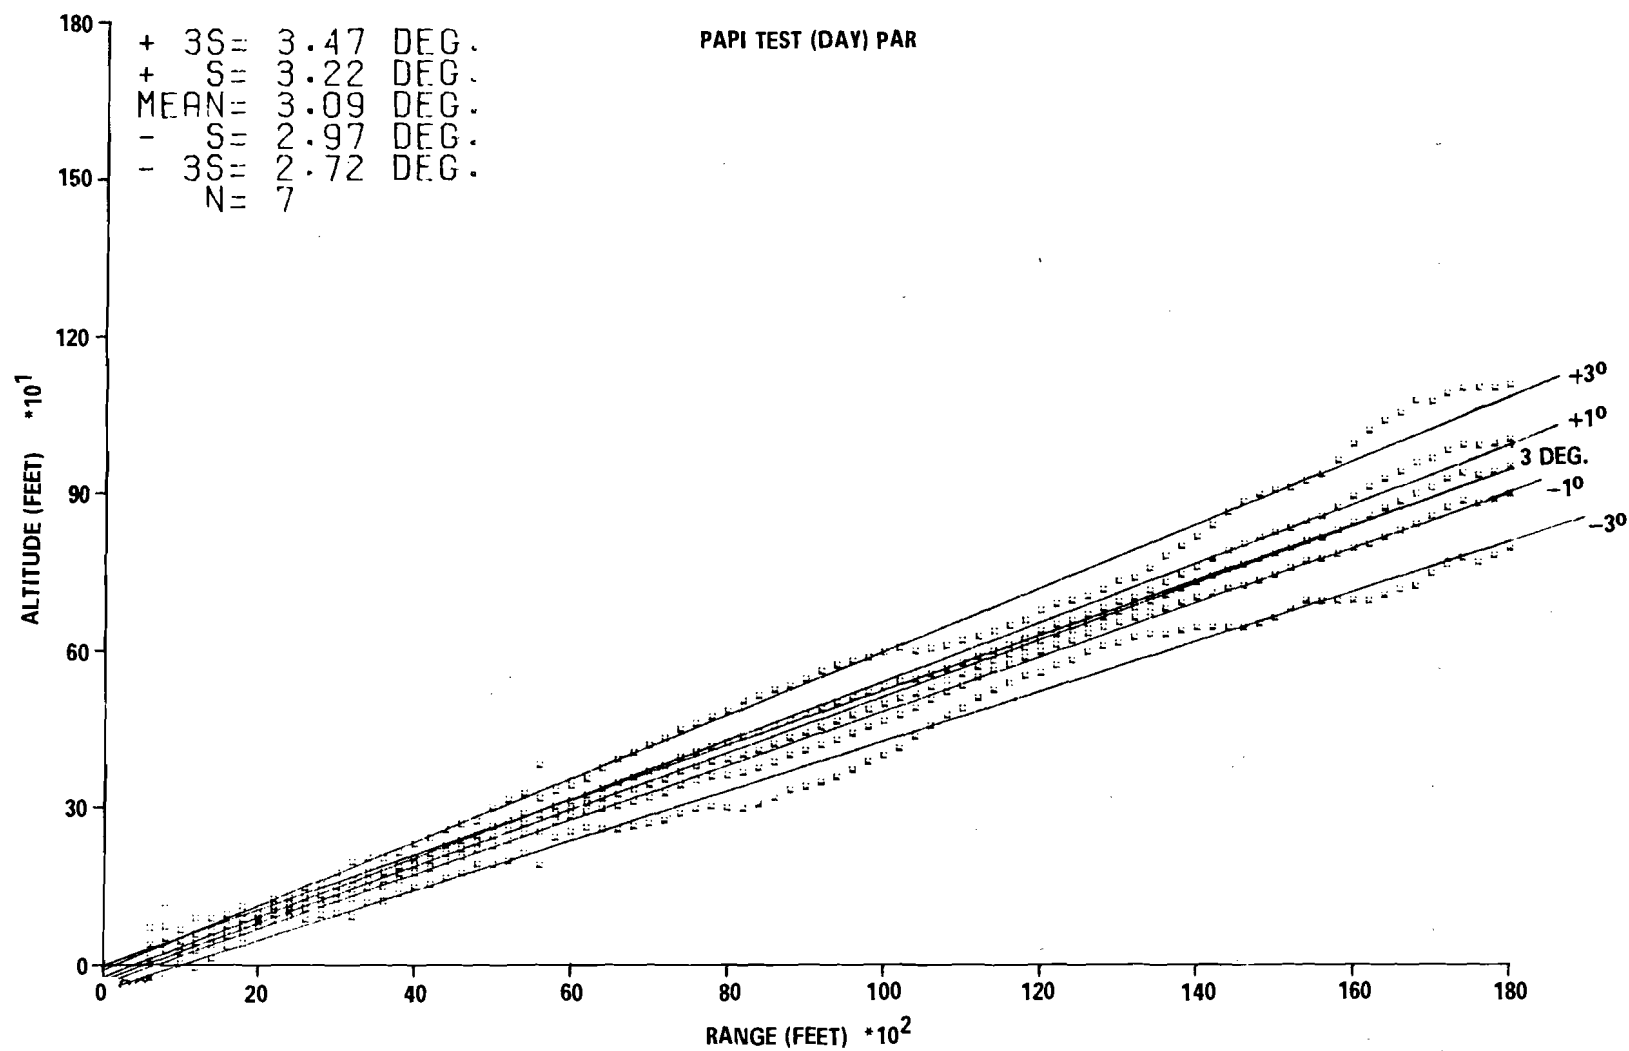
FIGURE D-5. PAPI STATISTICAL DAY PLOT

Attached as Appendix I is a compilation and summary of the data results of the questionnaires obtained from the test pilots during these tests. Also included are composite graphs, separated into daytime runs (figure 3) and nighttime runs (figure 4), showing the accuracy of the system as obtained by Radar tracking and reduced by our computer system. A statistical plot in figure 5

provides a graph that is broken down into 200 foot segments of range. Each range segment, when drawn together, provides a linear regression line. Lines representing the $\pm 3 \sigma$ deviation indicate that 99.74 percent of all aircraft flying the PAPI would remain within this corridor. The data obtained is offered without comment for this data report. Further testing of this type is planned and will be included in the final report of PAPI.

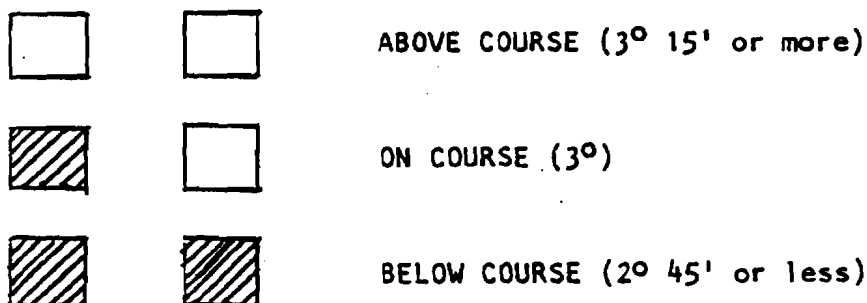
The tests now being conducted will provide data to determine whether a "Two Box" PAPI system can be successfully used on small airports with runways of 5,000 feet or less. The intended purpose of the "Two Box" PAPI is for use where it may not be necessary to have the five incremental paths provided by the full blown PAPI system. The arrangement of the units is similar to the full blown PAPI system except that only two boxes are used. The 3° glide-slope is midway between the angular setting of the pair of light units. The on-course signal is one red and one white light, the above course (greater than $3^{\circ} 15'$) is two white lights, and the below course (less than $2^{\circ} 45'$) is two red lights. These are depicted in the diagram below.

For this test, the units are located 1,000 feet down runway 4 on the right-hand side. Once you have accomplished a sufficient number of approaches to this system, please fill out the postflight questionnaire provided.
